Following document is a Progress Report submitted to National Science Foundation in September 2001 on my NSF funded WTC Project.

## World Trade Center Post-Disaster Reconnaissance and Perishable Structural Engineering Data Collection

**Objectives:** To conduct post-collapse reconnaissance investigation and to collect perishable data on World Trade Center Towers that collapsed and the buildings at the site that were damaged but not collapsed.

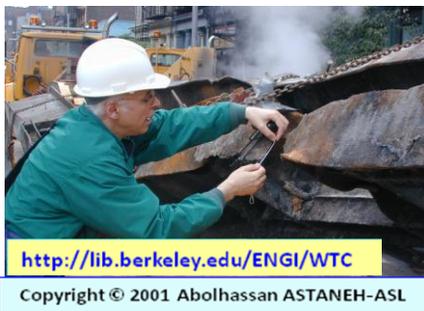
Fig. 1. A Beam from WTC-7 that is Burned

1. The photos in Figures 1, 2, and 4 are most likely showing steel from WTC 7. Other photos are most likely from the 110-story towers.
2. Photos in Figure 1 show the same steel beam. The beam is relatively minor member, most likely from a floor. Notice the duct openings on the beam web which is an indicator of it being a floor beam. Close inspection of the beam by this investigator (A. Astaneh-Asl) indicated that the distortion of the beam and fire effects and loss of some steel in this beam has occurred after the collapse. When this and other photos of this roll were shot, the beams on the truck, including this beam were still hot. As Figure 1 shows, in both photos is rising from the trucks and steel members. Scientifically, there is no possibility that the burning, melting and distortion of this beam could have happened when the beam was within the structure and carrying load prior to the 9/11 collapse. The reason is that if the beam was subjected to fire while in a building, as soon as the temperature of steel reached to about 500 degrees Celsius, much lower than the melting temperature of steel, the beam strength would drop to less than 50% of its original strength and the beam would collapse and would not have the chance to stay in its place and melt.

**Findings To Date:** During the 1<sup>st</sup> ten days of stay, most of the investigation was on the structure of Building 7 of the WTC. The 47-story structure was burning for almost 7 hours before it collapsed, Figure 1(a). During the 2<sup>nd</sup> 10 days of his stay in NYC, Dr. Astaneh has been able to establish contact with one of the recycling plants in New Jersey recycling the majority of steel from the WTC. He has conducted more systematic part of his investigation there. He has been able to investigate and document a large number of steel structural members. Some of his most striking achievements have been to identify and save at least four members (columns and beams) from the WTC Towers that appear to be directly impacted by a plane or were in the area of intense fire and eventual collapse.
