ANCIENT AGRICULTURAL FARMSTEADS IN THE RIO BEC REGION OF YUCATAN

Jack D. Eaton

Introduction

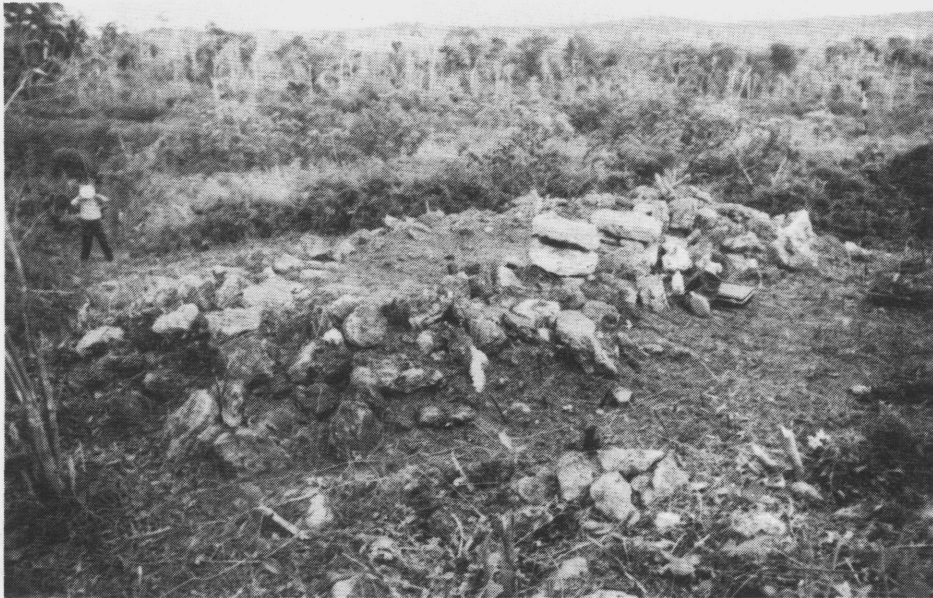
Plate 1a: Remains of house at Operation 10 before excavating. This is fairly typical of houses found in the region. Note the standing doorjamb.

Sub-Operation B included the excavation of Structure 1, the one-room rectangular house forming the west side of the complex. After bushing the site, and before excavations began, the outline of the house walls could be made out rising slightly above fallen stones and accumulated forest debris (Plate 1, a). This is typically how all of the structures identified as houses were found.

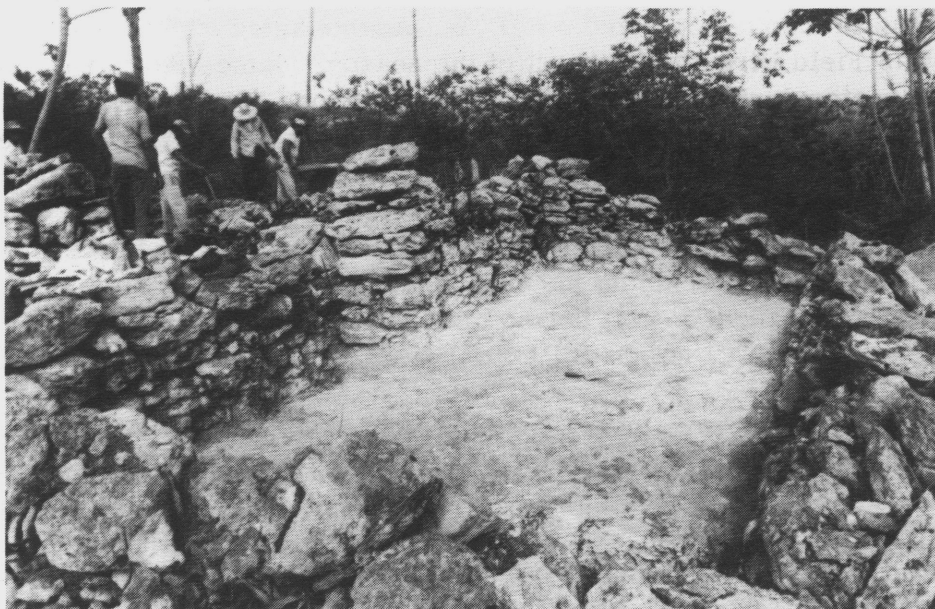
Plate 1b: Interior of house at Operation 17-C. Note wall construction and plaster floor. Shown here is a typical farmstead house of the region.

Sub-Operation C; Structure I, forming the north side of the complex, is a one-room house with a doorway facing the court. The house walls are built of rough stones and slabs which appear to have been laid dry. There is no evidence of wall plaster. The walls are presently about 70 cm. to 1.0 m. in height, but originally were over 1.5 m. high. The thickness is about 60 cm. The house roofing was probably thatch. The doorway is 90 cm. wide and is built of large slabs which are cut flat to form the jambs. The west doorjamb presently stands 1.5 m. high. The room inside dimensions are 2.45 m. wide by 5.45 m. long. The long axis is east and west, but a ctually oriented roughly 20° east of true north (Plate 1, b and Figure 5).

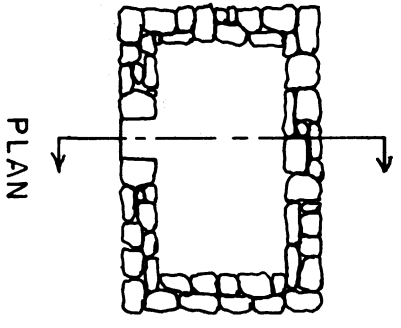
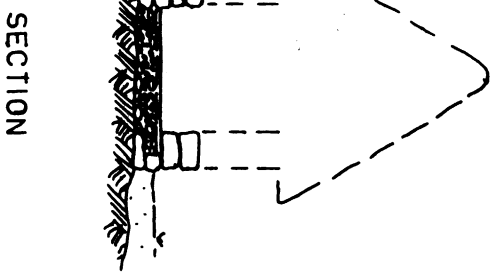
Figure 4

OPERATION 17 B
House at Km 158.2
East of Xpuhil

Sub-Operation B is a small one-room house located approximately 50 meters southwest of sub-Operation A. The house is rectangular in plan and faces south (Figure 6). The building is oriented about 21° east of true north. The walls are built of crude stones that appear to have been laid dry. A doorway 65 cm. wide is approximately centered in the south wall. Forming the door jambs are large slabs which are roughly faced. The walls presently rise about 60-80 cm. above the floor level, but originally were probably around 1.7 m. in height. They are roughly 60 cm. in thickness and give no hint of wall plaster. The walls probably supported a thatch roof as shown in the suggested restoration drawing (Figure 4).
