SONOMA MISSION:
AN ARCHAEOLOGICAL RECONSTRUCTION OF THE
MISSION SAN FRANCISCO DE SOLANO QUADRANGLE (1)

Adan E. Treganza

I. INTRODUCTION

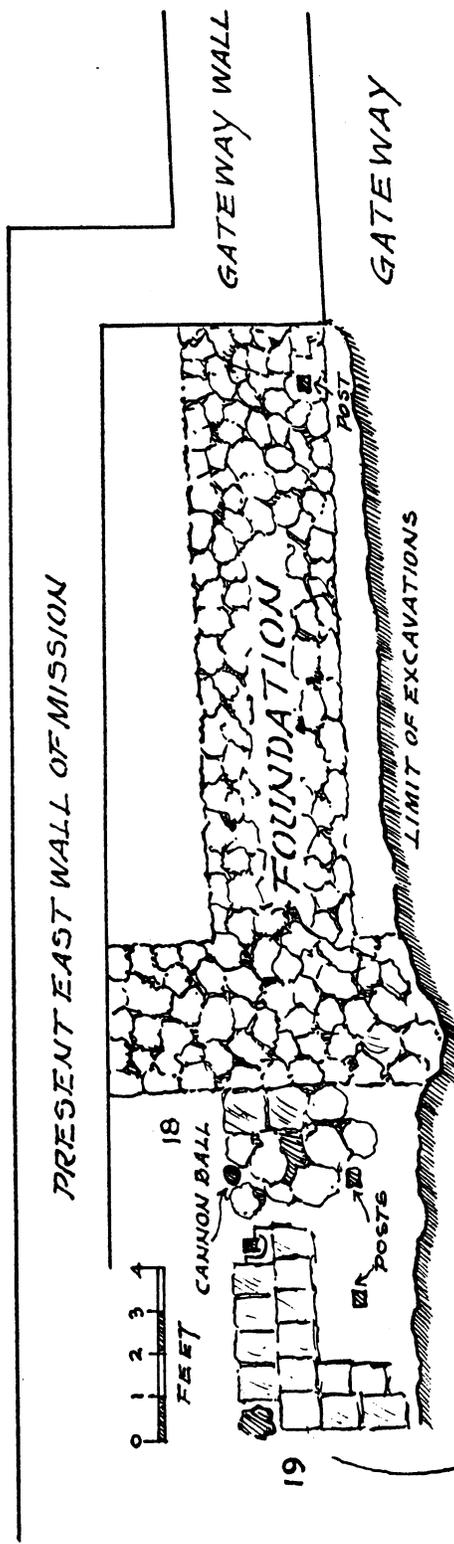
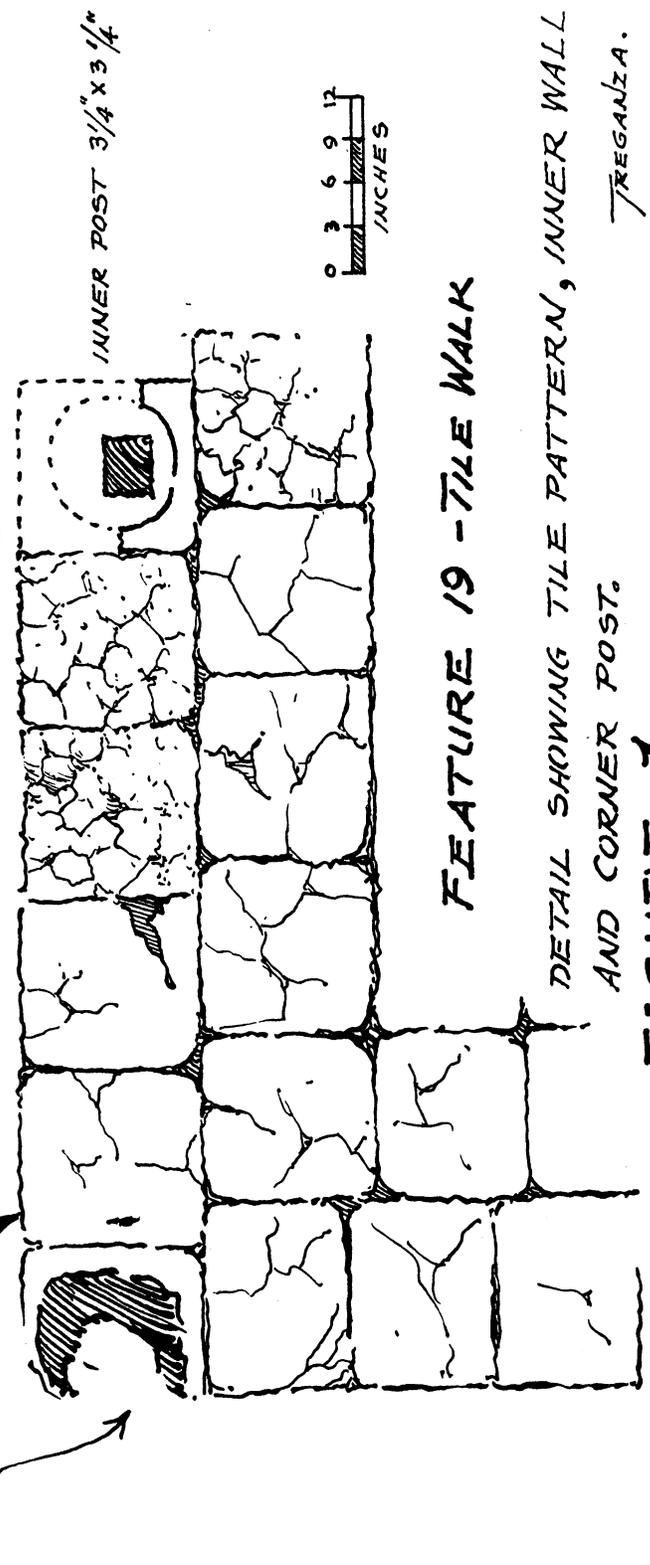
FIGURE 1

- Figure 1. Tile walk and foundation of Priests' House at southeast corner of Mission Quadrangle. Feature 19, detail of tile walk.
- Figure 2. a. Ground plan of Building C.

TILE WALK AND FOUNDATION OF PRIESTS' HOUSE
AT S.E. CORNER of MISSION

FEATURE 19 - TILE WALK

DETAIL SHOWING TILE PATTERN, INNER WALL POST AND CORNER POST.

Building A was paralleled on its north side by a tile walk and drain eight feet wide. The walk probably was originally roofed over, as is the front of the present museum. The east end of the walk and drain have been considerably disturbed by drainage ditches; however, we were able to establish the eastern end of this walk as is shown in our Feature 19 (Fig. 1).

2. Feature 19 (Pl. 1d; Fig. 1). This is a remnant marking the end of the tile walkway which formed the north side of the Priests' House. It is the fully exposed area which Bennyhoff and Elsasser thought might represent a walk along the west side of the Adobe Church.

Some detail is given here (Fig. 1) since the tile pattern may be of interest in future reconstructions. The outside corner is marked by a definite post hole which would have adequately taken care of a 6" by 6" post; however, no wood fragments now remain. Because of the size of the post no attempt was made to cut a tile to fit around the wood as in the case of the smaller inner post (Fig. 1) located midway between the foundation of the Priests' House and the corner of the tile walk. The inner post measured approximately 3-1/4" by 3-1/4" and was set in a circular hole in the tile. Judging by the abrasion marks on the tile, it is assumed that the hole, rather than representing a tile originally cast with a circular hole, had been chipped out and ground smooth. A similar situation was noted for two post holes in Building C.

In general the tiles which form the walk are inconsistent in their size, ranging from 9" x 9" to 13" x 13", with various combinations between these two extremes. Rarely do perfect squares occur. Bennyhoff and Elsasser suggest that the tiles might have been made in several different sized press molds. I would rather assume, on the basis of the varied dimensions and the irregularity of the surface on the underside of the tile, that they were made by compressing damp clay between two flat sticks, alternately forming the sides. The irregular upper surface thus formed became the nether surface when laid. Once sun-dried, the tiles probably were fired at a temperature under 1000° F., since all are soft and have the dark, "reduced" interior. As earlier noted the width of the walk is 8 feet. In the report of the 1953 excavation, Bennyhoff and Elsasser observed a small portion of our Feature 19 and correctly interpreted it as part of the walk along the north side of the Priests' House, with an alternate suggestion that it might possibly represent a fragment of walk on the west side of the Adobe Church. The point in question is more fully discussed in the present report under the section "Relationship Between the Priests' House and the Location of the Adobe Church" (p. 7).

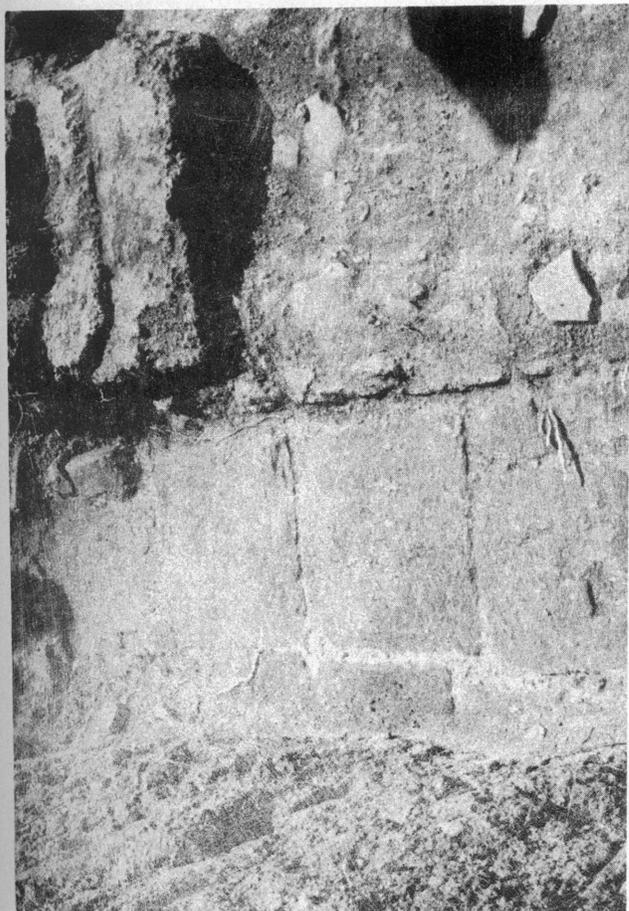
d

d. Northwest corner of Building C showing interior tile and foundation.
- Plate 3. a. Adobe wall forming the south side of Building C.
b. Detail of adobe wall forming south side of Building C.

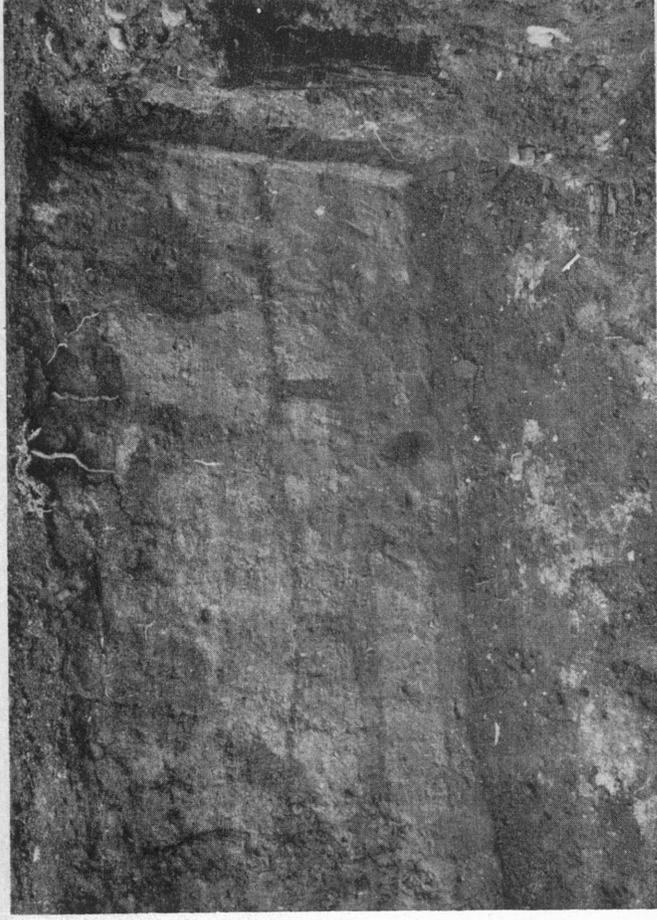
c. Detail of crushed roof tile forming the doorway threshold of Building C.
d. Detail of adobe brick on foundation along south wall of Building C.
- Plate 4. a. Foundation of Priests' House extending under present east wall of Mission.

4. Test Pit 4. This was placed at the end of the present gateway in order to determine if the foundation of the Priests' House continued in an easterly direction. Positive evidence of a foundation does indicate a continuation of this structure.
