## SQUIER'S "PALACE OF OLLANTAY" REVISITED

Alan R. Sawyer

## Introduction

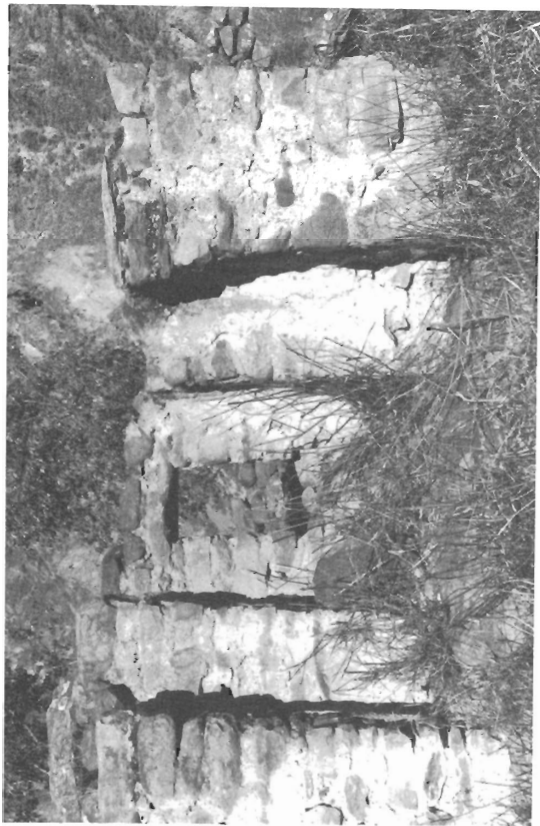
15

Plate XIV. Fig. 15, double jamb niche with window in west wall of Structure D; fig. 16, fragment of north second story wall of Structure E with Chávez on central axis; fig. 17, tall niche with window in south wall of Structure E; fig. 18, east façade of Structure F, traces of wooden lintels, now removed, in niches.

The 1.9 m. thick west and east walls of Structure D are the most elaborately niched at Q'ellu Raqay. They are in mirror symmetry, with each featuring four tall niches on its interior side alternating with three windows that open to the inner face of large double jamb niches on the exterior (fig. 15). The elaborate structure may have been roofed over but there is no trace of the perishable materials of which a roof would have been made.
