PRELIMINARY SITE SURVEY OF THE PUNKUYOQ RANGE, SOUTHERN PERU

Stuart White

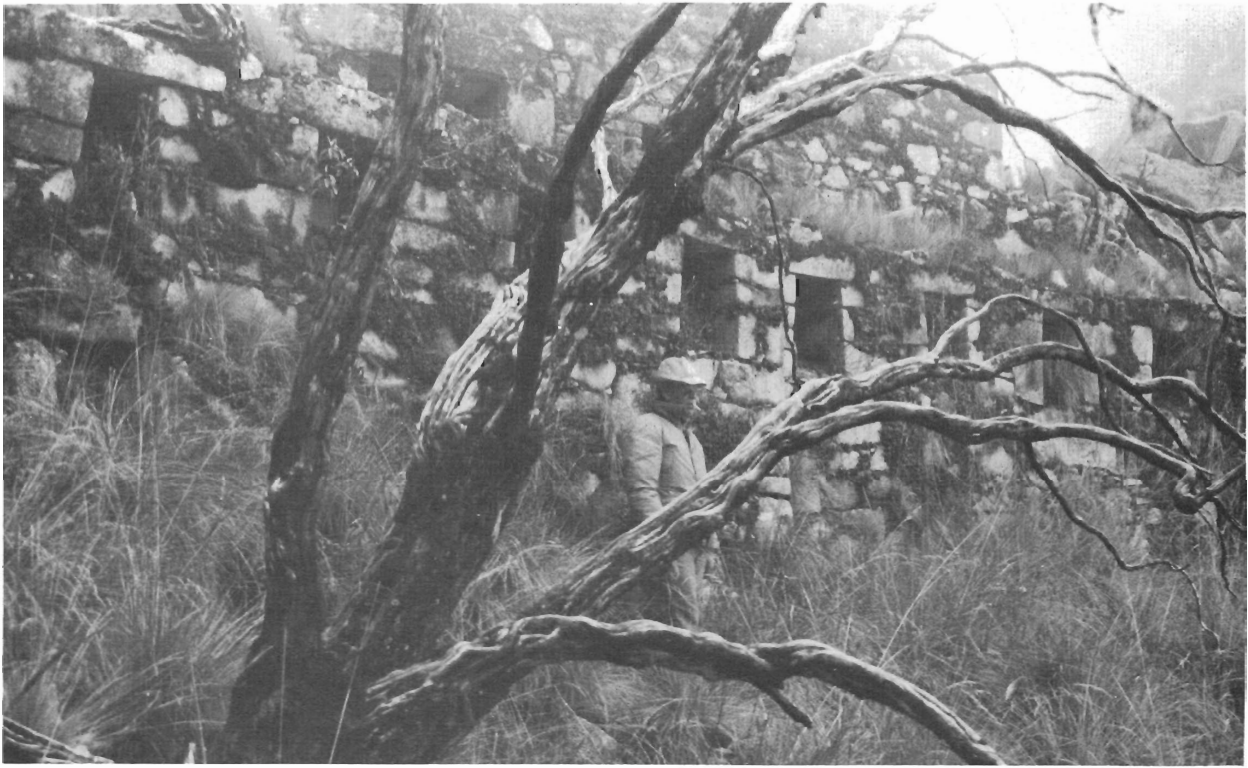
18

Fig. 18, Inka Wasi, retaining wall forming terrace in front of main door on west side (figure is Robert von Kaupp); **fig. 19**, road leading to Inka Wasi.

Retaining walls (fig. 18)

There are various retaining walls at Inka Wasi (fig. 6, 1b). They are found on the north, west (fig. 18), and south sides of the site. Those on the north side help form a small plaza at the level of the large flat rock (fig. 6, 1c) between Inka Wasi and two rectangular buildings (fig. 6, 1e and f). This flat rock is natural, but it appears to have been worked in order to perfect and level its surface.

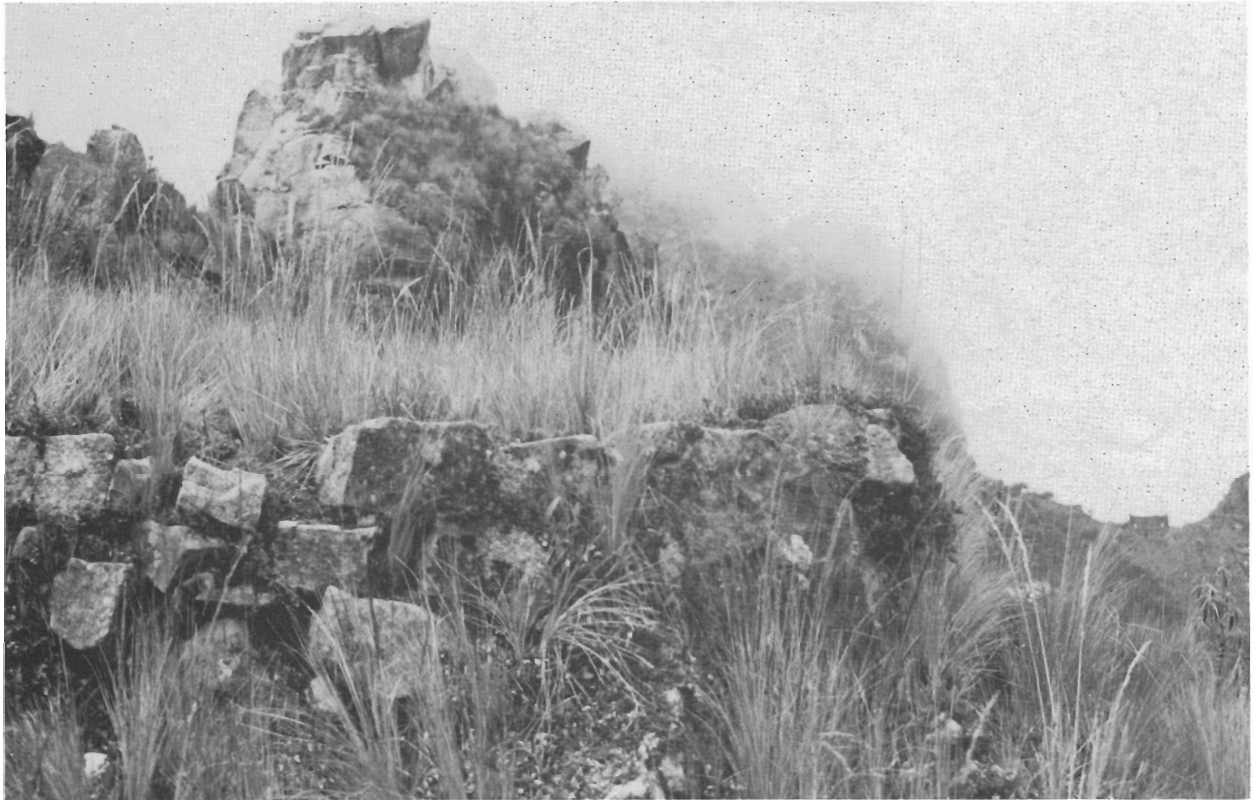
23

Fig 23, Platform A (site 2) from the southwest (Inka Wasi is located on the ridge at the right edge of the photograph; **fig. 24**, Platform B (site 3) from the north (the isolated rock to the left is unmodified).

Platform A (site 2; fig. 23)

This platform is on a narrow ridge to the west of and almost directly opposite Inka Wasi, at 3820 m. It is small and about square (4 m. on each side), built in two stages or levels, and of fairly rough stonework.

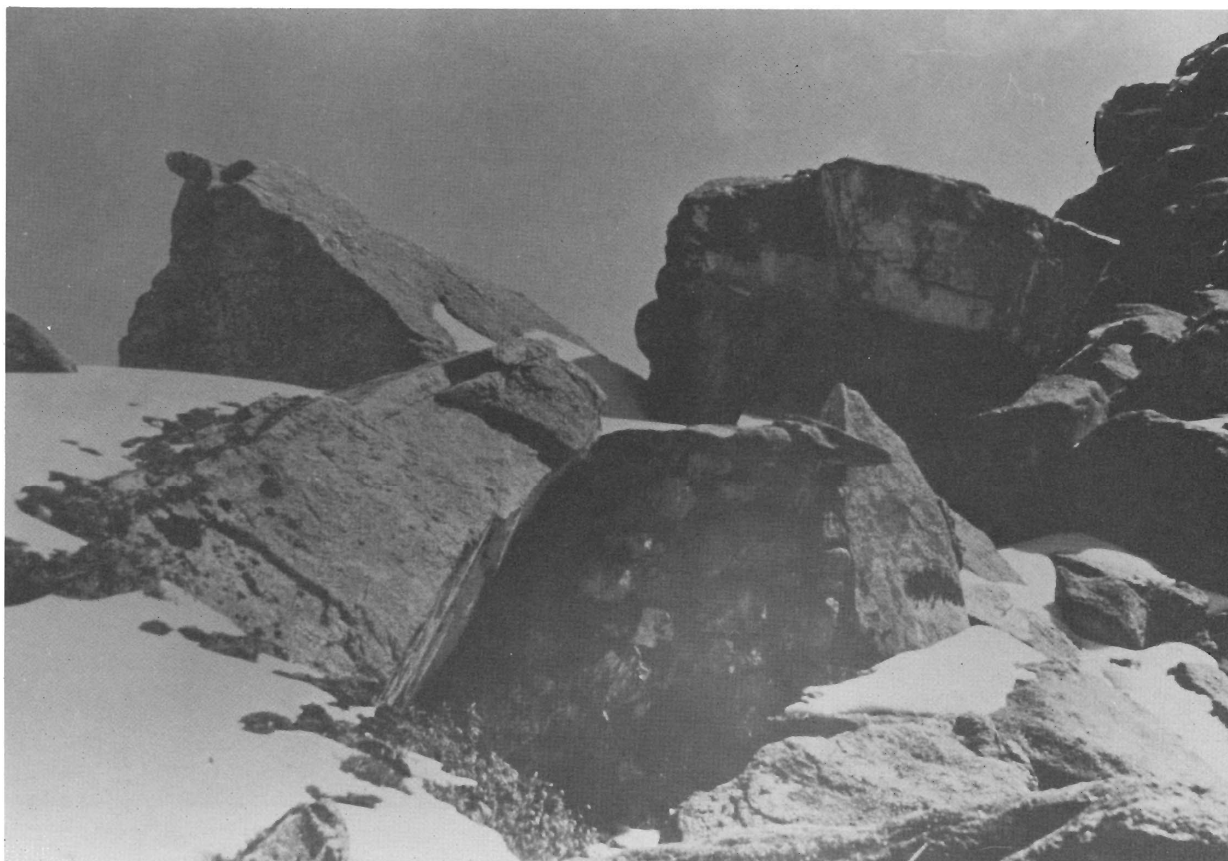
**25**

Fig. 25, Platform C (site 4) from the southeast; **fig. 26**, Platform D (site 5) from the south (figure is Lynn Hirschkind).

Platform C (site 4; fig. 25)

A platform located on the top ridge of Cerro Idma at 4350 m., a short distance from the mountain's summit. When I saw it, the platform was covered with snow, but it appears to be of one level, and measures 6 × 10 m. It is oriented towards the Idma Qoya side of the ridge, and has on its top surface a border of flat stones that project slightly from the edge.

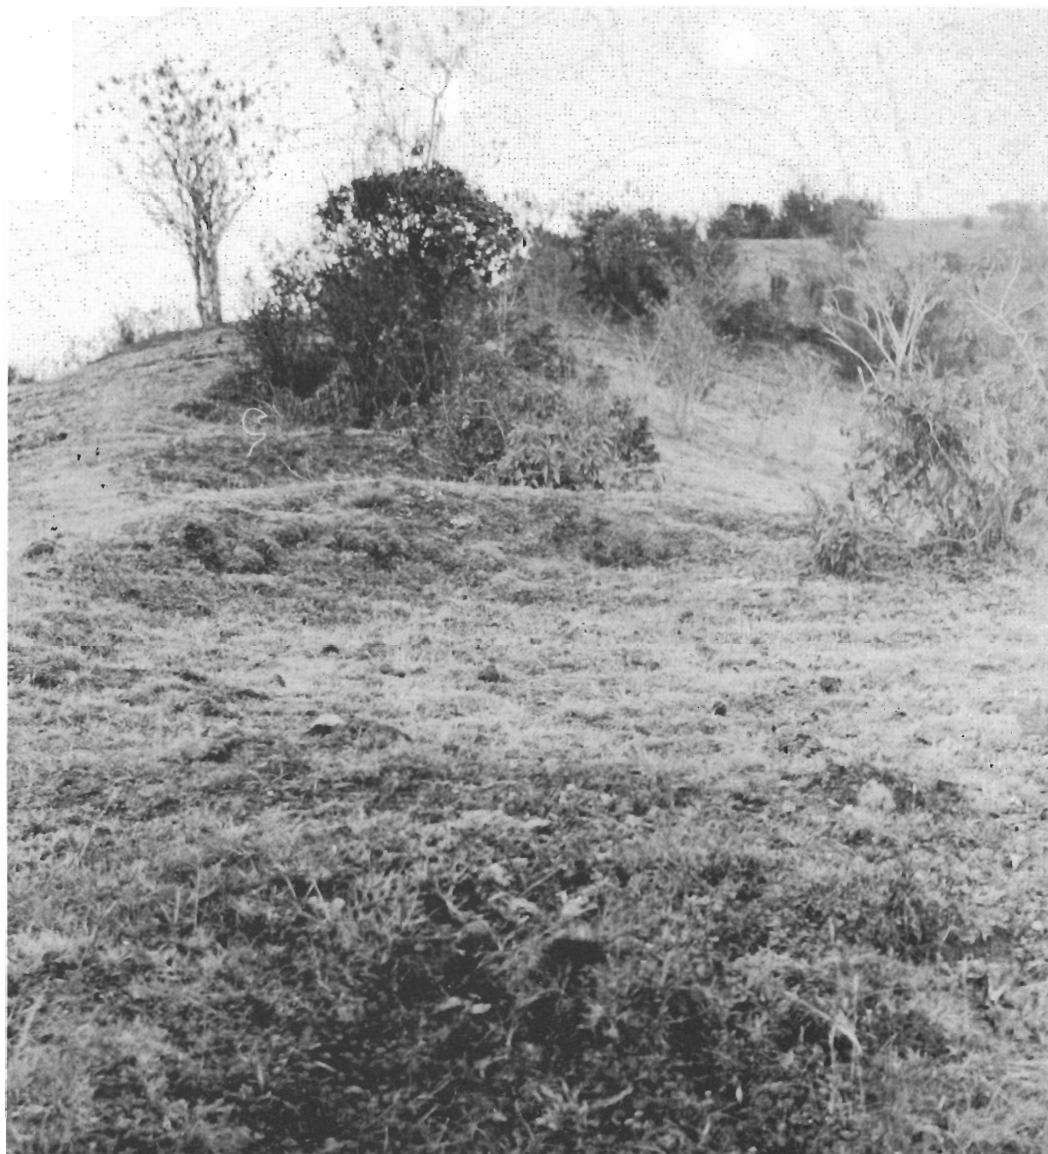
29

Lump'u Moqo. **Fig. 28**, site from the west northwest; **fig. 29**, remains of circular structures.
