FORT ROSS

A STUDY IN HISTORICAL ARCHAEOLOGY

By Adan E. Treganza

Report on archaeological investigations at
Fort Ross State Monument in the summer of
1953 carried out by the Department of
Anthropology, University of California,
and in cooperation with the California State
Historical Resources Division

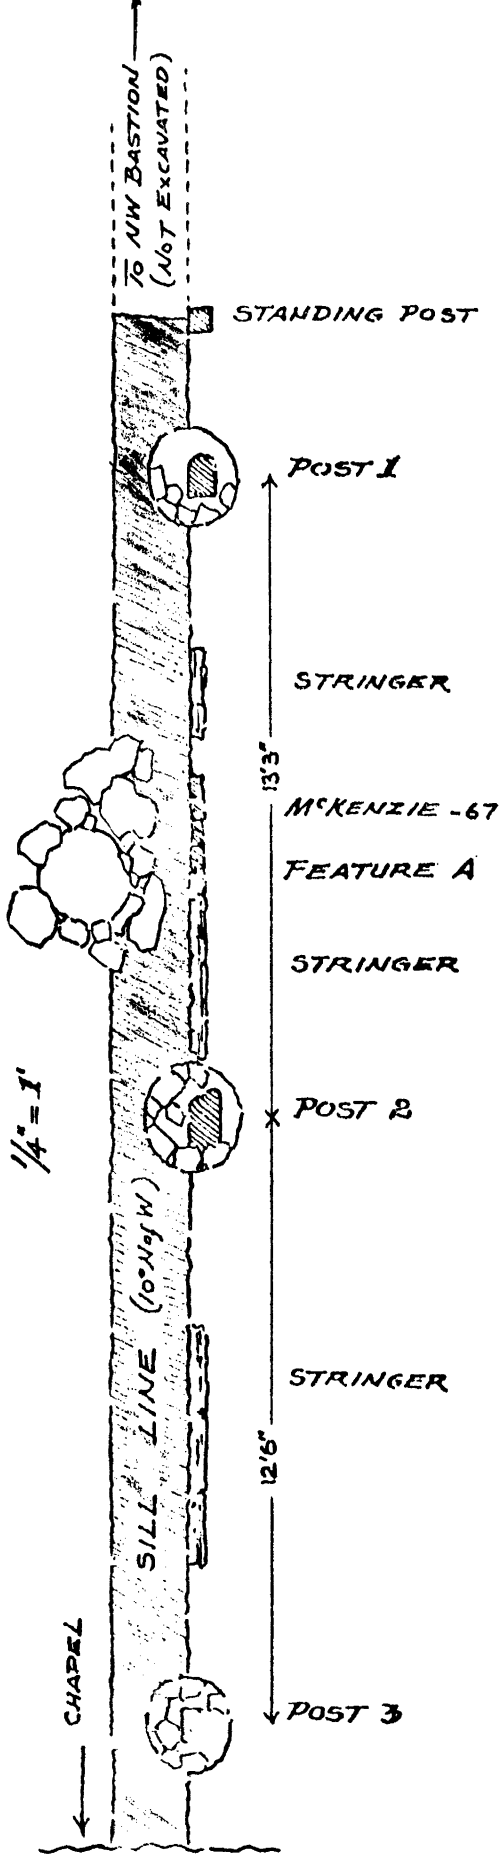
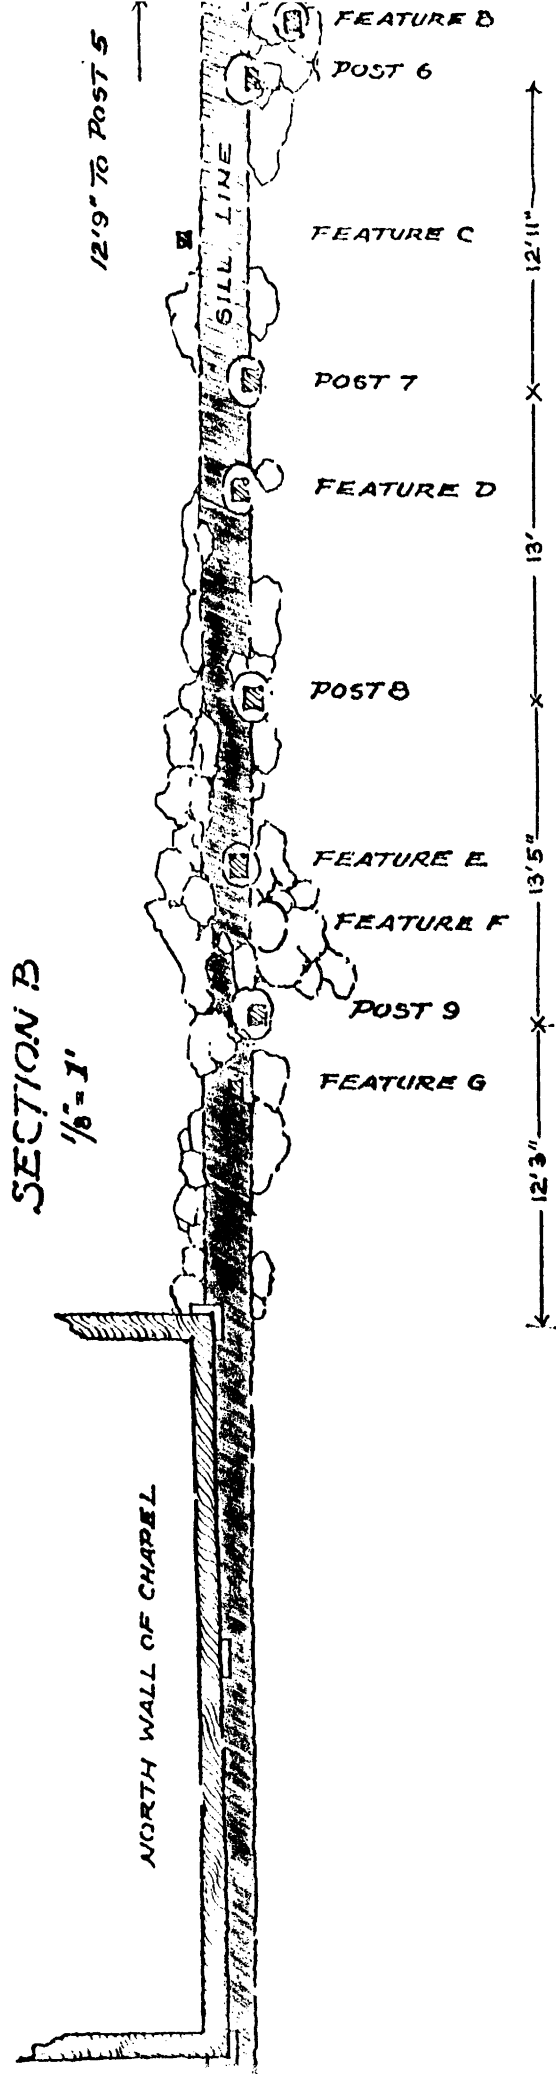
FIGURE 1

SECTION A

SECTION B

DETAIL OF EXCAVATIONS ALONG NORTH STOCKADE WALL

Section A, as well as Section B, follows the area excavated earlier by Mr. McKenzie, but being favored with more help, we were able to extend our operations over a wider area and thus expose several new features, which collectively provide a rather definite pattern of stockade construction (fig. 1).

Stockade Walls: The general notes are derived mainly from the north line which runs between the northwest Bastion and the Chapel (fig. 1). The sill which was detected on all four sides of the Fort ranged in width between 18 and 20 inches, averaging 30 inches below the ground surface (Pl. 1, fig. d). Attempts by the Russian builders to maintain a level sill base may be noted along the north line where bedrock tends to surface and a trench had to be cut into the resistant yellow sandstone. Only rarely were fragments of the wood sill still present. Its horizontal position and frequent mortise holes for the puncheons have not been conducive to preservation. To support the super-structure the size of the sill must have been at least 8 x 16 inches. There are no positive data on this point. Bowen refers only to a "strong girder."

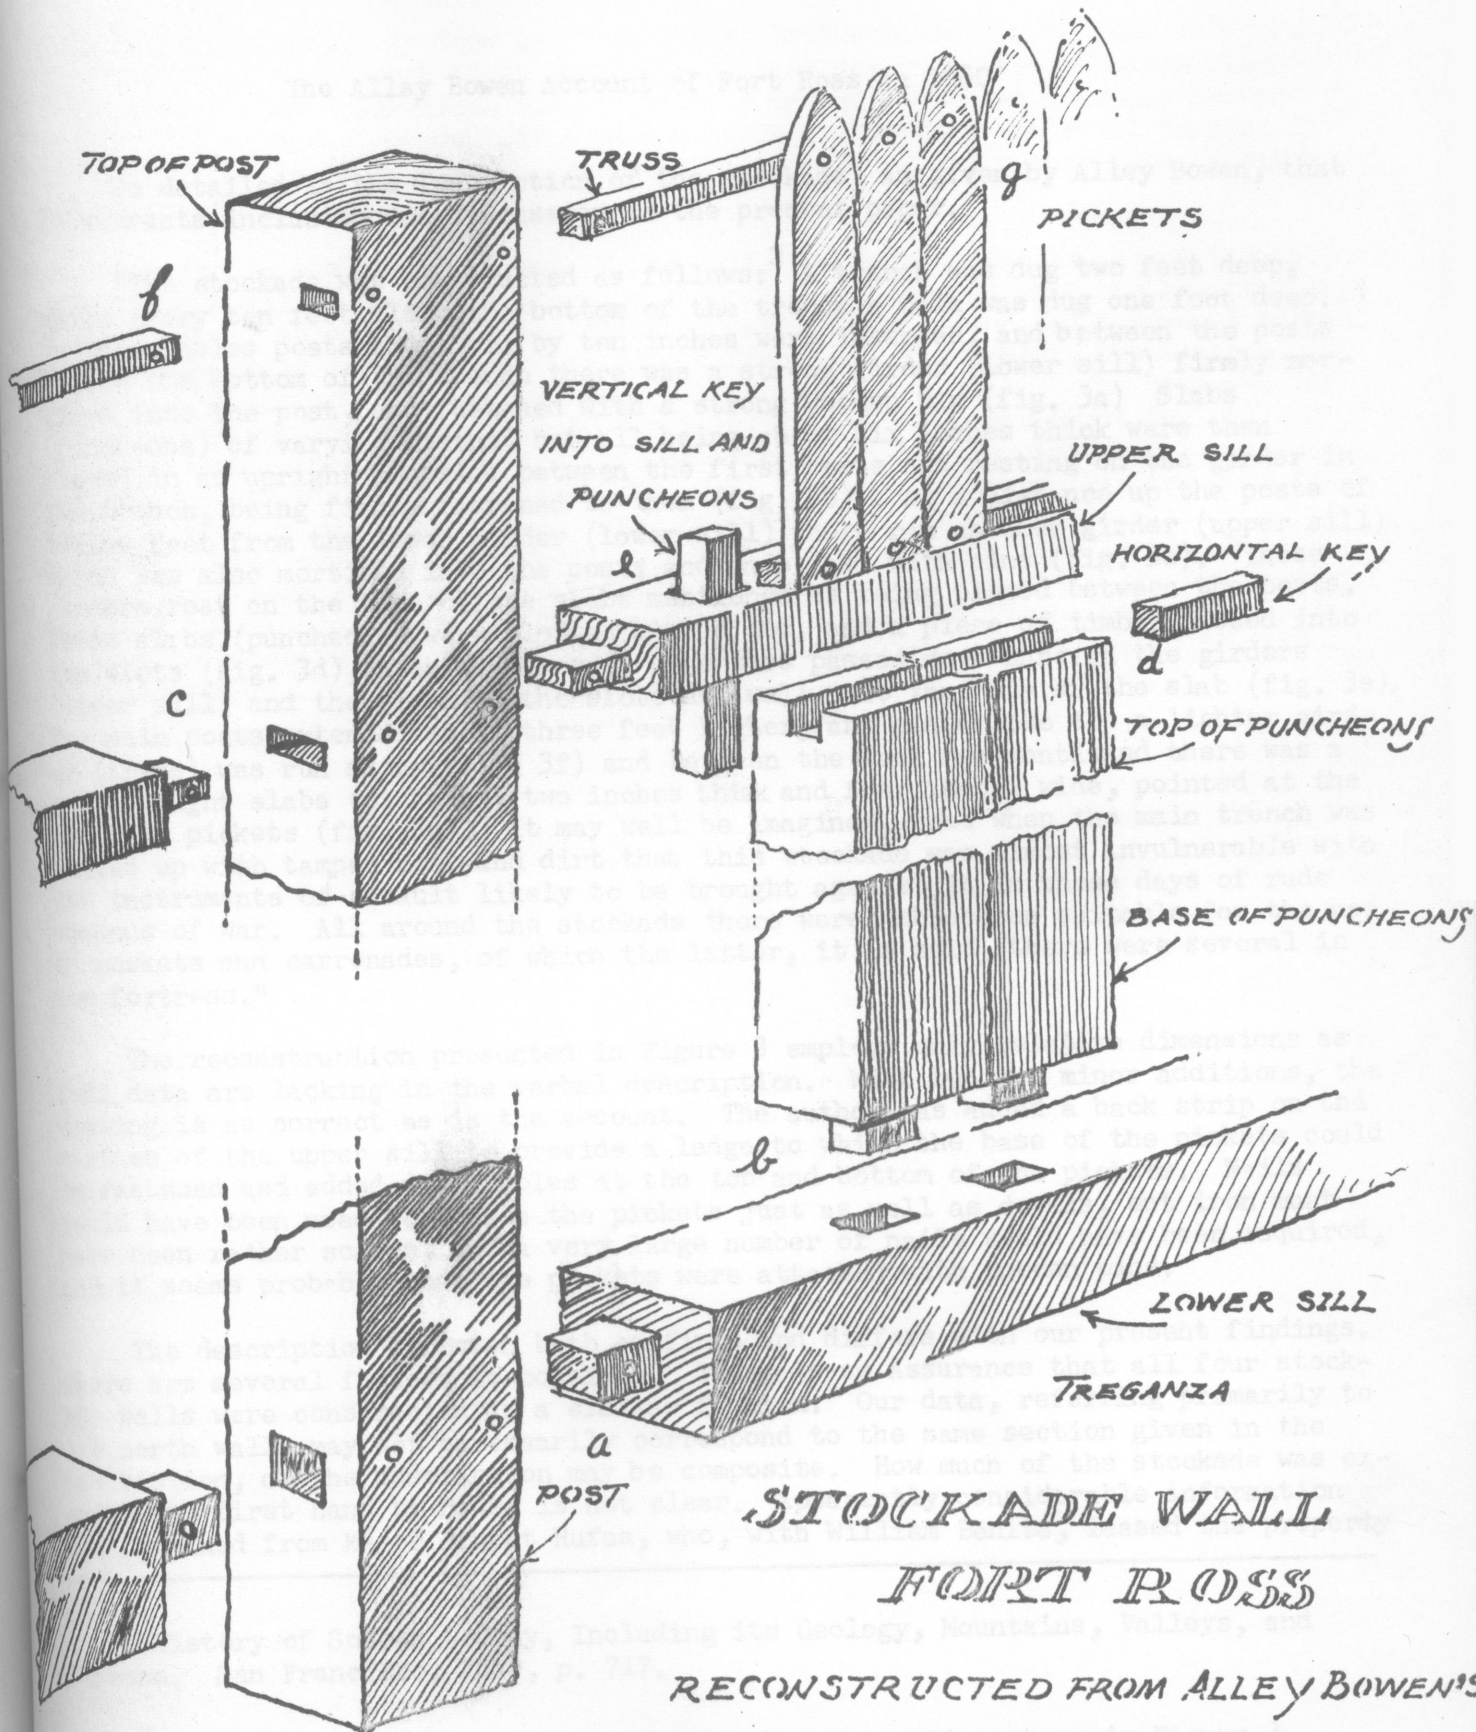
**STOCKADE WALL
FORT ROSS**

RECONSTRUCTED FROM ALLEY BOWEN'S
VERBAL DESCRIPTION IN 1880

The precise way in which the sill contacted the main posts is not clear. The Bowen account (fig. 3a) states that the sill was mortised into the post and speaks of the posts as being only 6 x 10 inches. Our data, derived from eight posts along the north wall, show very definitely that the rear of the posts makes contact with the sill at about its midpoint and the outside of the posts protruded beyond the outer edge of the sill as much as 8 inches. Figure 2c diagrammatically illustrates this point and plate 2, figure e, shows it in reality. In one case (Pl. 1, fig. e) the entire post lies beyond the outer edge of the sill. Those who observed the relationship in situ concluded the sill notched around the post being held firm with a dowel (fig. 2c).

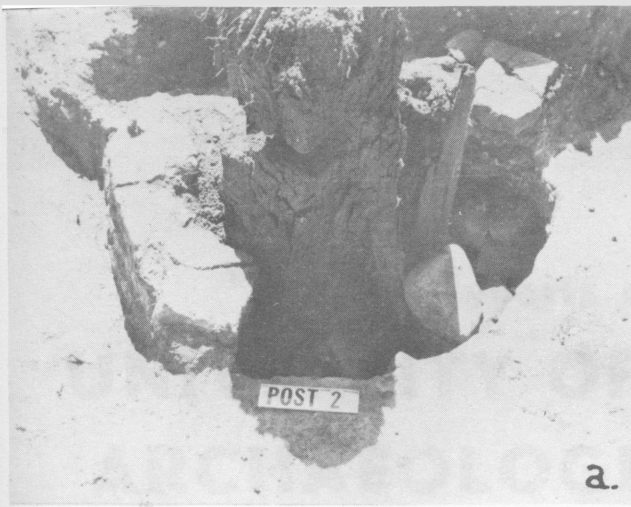
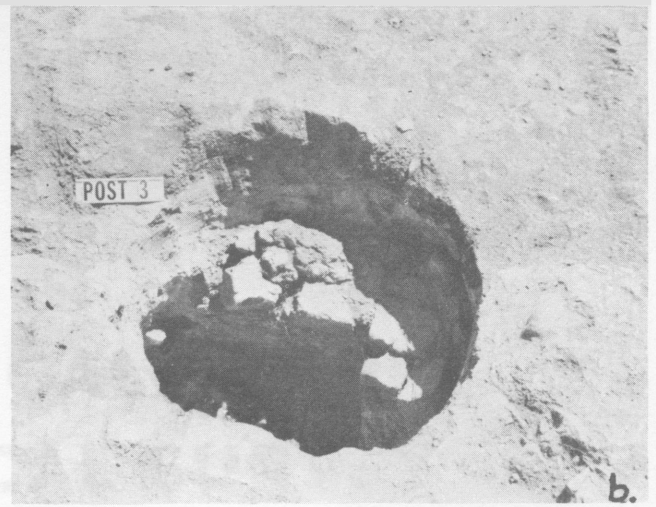
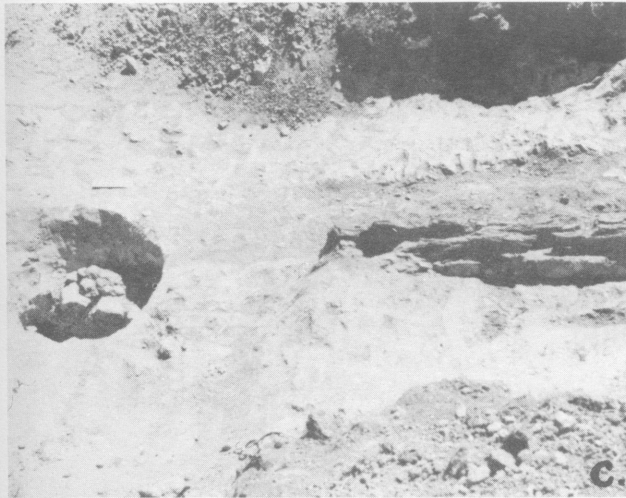
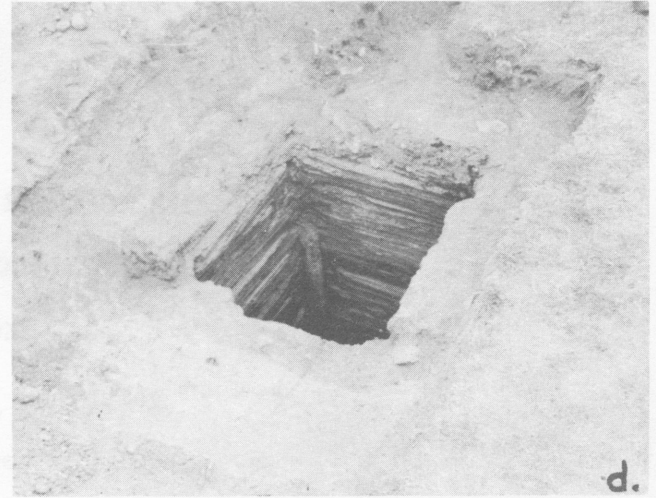
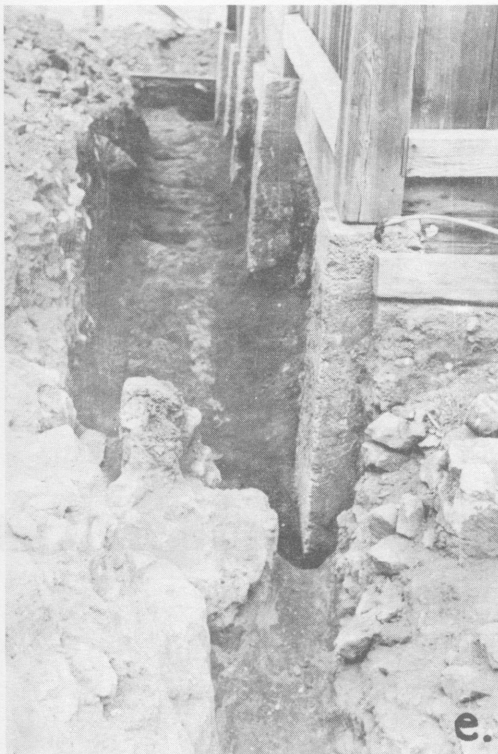
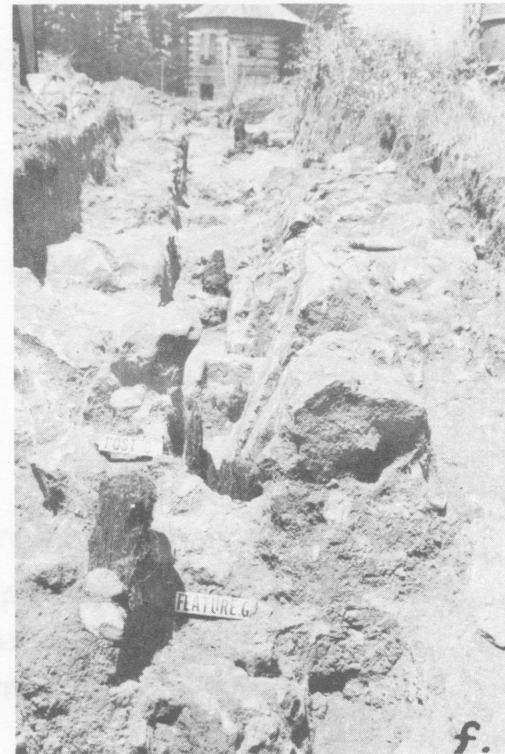
Plate I. Archaeological Features at Fort Ross

Explanation of Plate 1.

Archaeological Features at Fort Ross

- a. -- Post 2. Showing remains of original post with dowel hole on left side. Note well defined post hole and arrangement of bricks at base of post.
- b. -- Detail of post hole 3 showing sill line, post impression, and rock fill.
- c. -- Post 3. Showing sill line intersecting post hole with a remnant of stringer along the edge of the sill.
- d. -- View of well showing post-Russian cribbing. The dark area around the cribbing represents the outline of the original Russian well.
- e. -- View along north wall of chapel showing error in respect to the outer edge of the stockade. Arrow indicates position of original corner.
- f. -- View looking west through sections B and A. Shows sill line, rock fill, and northwest bastion in the distance.

The well (Pl. 1, fig. d), as noted, has had two distinct histories presented as Russian and post-Russian. The latter is to be seen in the present inner red-wood cribbing. The original Russian portion is represented by the dark soil area about 6 feet in diameter which encircles the cribbing. With its central location the well could provide an interesting tourist attraction. If water is desired for the present occupants of Fort Ross, I would suggest a second well be drilled in the near vicinity rather than disfigure this interesting feature. If a false bottom were placed in the well and pipes brought in below this bottom or eye-level, the present well might still serve the dual function of display and current water supply.
