HIGHLAND INCA ARCHITECTURE IN ADOBE

Elisabeth L. Moorehead

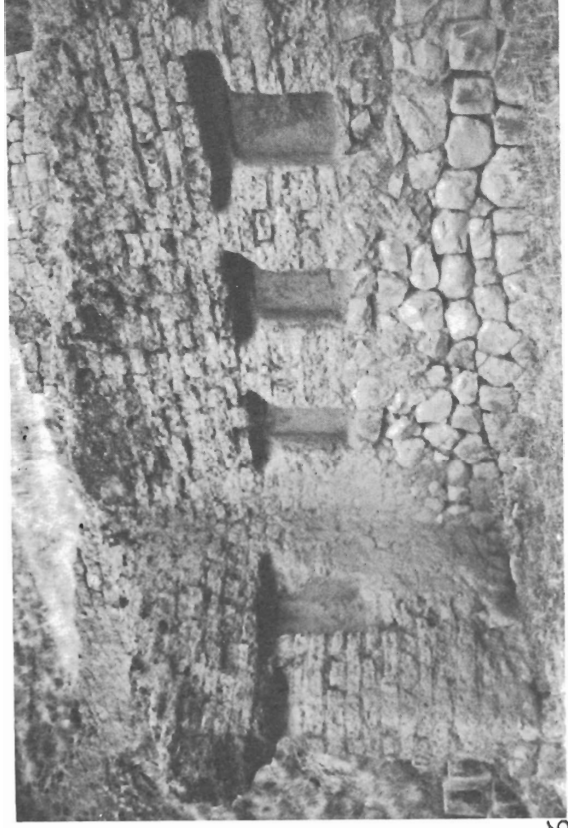
26

Fig. 26. Interior of northwest corner, Mirador, Písacllacta, showing drop in height of stone foundations, preserved plaster, and bond of brickwork.

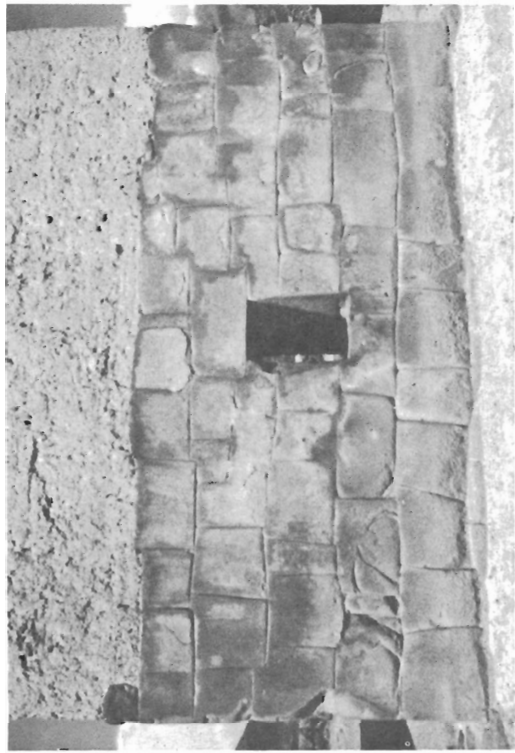
35

Plate XXV. Temple of Viracocha at Cacha; see fig. 33 and Key to Illustrations.

In the stone part of each of the center wall piers is a window (fig. 35). As windows go, these do not offer much view of one hall from the other, for they are no larger than the common niche at Hospitalniyoc yet they perforate a wall 1.70 m. thick. Therefore, unless they served some unknown ceremonial purpose, they are primarily a decorative feature giving strength to a hypothetical pattern of niches and/or windows in the no longer extant east, west and north perimeter walls. Toward the top of the stone portion of the piers, there are small, square holes visible from within the doorways between piers (fig. 34). One possibility is that these holes held a pole across the doorway which perhaps supported some kind of curtain.
