Improving Situational Awareness to Reduce the Wild fire Risks of Operating Power Distribution Infrastructure

Technical Report No. UCB/EECS-2022-244

**Improving Situational Awareness to Reduce the Wildfire Risks of
Operating Power Distribution Infrastructure**

Research Project

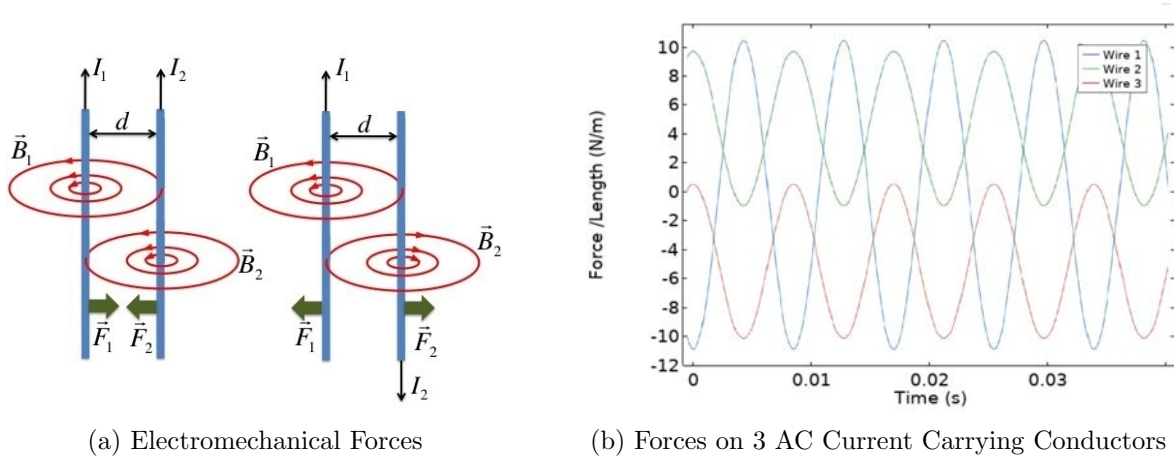
Figure 3.1: Forces on 3 phase AC conductors

$$\hat{F}_1(i, d, l, t) = \frac{1.26 \cdot 10^{-6} \cdot i^2 \cdot l [\sin(120\pi t) \cdot (2 \cdot \sin(120\pi t + \frac{2\pi}{3}) + \sin(120\pi t + \frac{4\pi}{3}))]}{4\pi d}$$

$$\hat{F}_2(i, d, l, t) = \frac{1.26 \cdot 10^{-6} \cdot i^2 \cdot l [\sin(120\pi t + \frac{4\pi}{3}) \cdot \sin(120\pi t + \frac{2\pi}{3}) - \sin(120\pi t) \cdot \sin(120\pi t + \frac{4\pi}{3})]}{2\pi d}$$

$$\hat{F}_3(i, d, l, t) = -\frac{1.26 \cdot 10^{-6} \cdot i^2 \cdot l [\sin(120\pi t) \cdot \sin(120\pi t + \frac{4\pi}{3}) + 2 \cdot \sin(120\pi t + \frac{2\pi}{3}) \cdot \sin(120\pi t + \frac{4\pi}{3})]}{4\pi d}$$

Equations 3.1: Forces on 3 parallel AC current carrying conductors

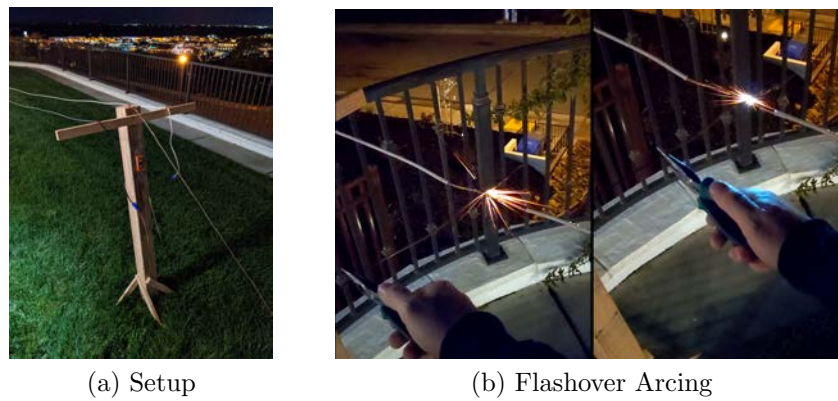
Figure 4.1: Flashover Arcing Experiment

To explore Questions 1 and 2, a physical experimental setup was constructed to simulate the occurrence of flashover arcing and vegetation on a span of conductors. 50 feet of parallel 0 gauge insulated copper conductors was supported by two 6 inch by 6 inch pine timber posts and two pine cross arms. An over-current protection device was installed in an enclosure mounted on one of the posts to connect a 110V mains lead to the 0 gauge conductors. The conductors were unsheathed at 10ft intervals to facilitate phase to phase fault currents. A 12 gauge copper conductor was used to intermittently bridge the live and neutral conductors and cause flashover arcing. An Endaq S3-E25D40 Piezoelectric accelerometer was attached to the other post and 126 measurements were obtained across multiple conditions. Vibration measurements across 3 axes were captured at a sampling rate of 20kHz during 10 flashover arc events, 55 vegetation contact with no arcing events, and 60 time intervals during serene

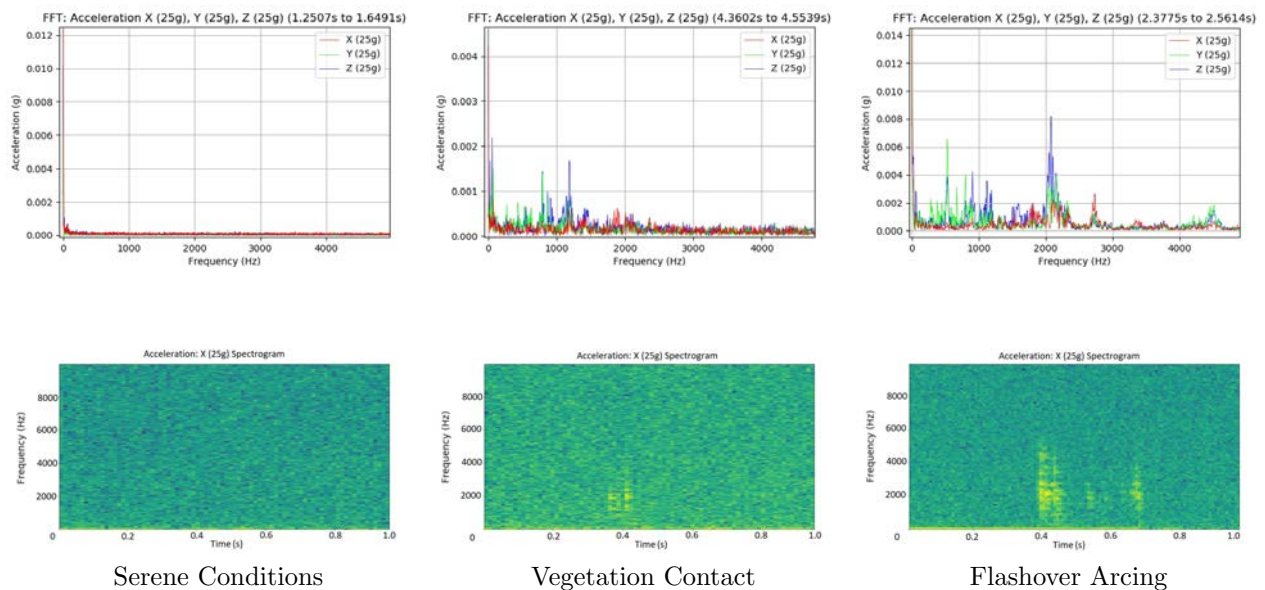
Figure 4.2: Frequencies detected on post during Flashover Arcing Experiment

conditions. The measurements were truncated to ± 0.5 seconds around the event, then down-sampled before a FFT was performed to transform the data into 512 frequency amplitude buckets. A K-neighbors classifier was trained using these measurements with a 25% training split. The classifier performed with 91% accuracy on the test data set. The preliminary

data suggest that acoustic emissions from flashover arcing and vegetation on a conductor is likely to be detectable by an accelerometer attached to the wooden pole compared with

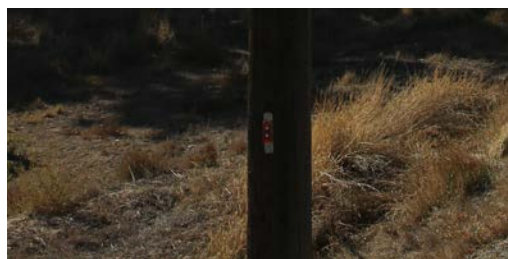
(a) Setup

To explore Questions 3 and 4, measurements were obtained from 103 in service wooden utility poles located in Grand Junction, Colorado. The poles were professionally inspected with sound and bore tests 7 days prior to taking the measurements and 13 poles were determined to contain internal heart rot or decay. An Endaq S3-E25D40 Piezoelectric accelerometer was temporarily attached to each pole at heights of 10cm and 110cm with 2 screws torqued to 21Nm. The accelerometer was positioned so that the z-axis was always parallel with the conductors supported by the pole. 30 second measurements were captured at a 20kHz sampling rate, then downsampled before a FFT was used to transform the signals into 7000 frequency buckets. A K-Neighbors classifier was trained using these measurements with a 25% training split. The classifier performed with 83% accuracy on the test data set correctly identifying 3 of 3 sensors as having heart rot/decay and misclassifying 3 of 15 sensors as having rot where none existed. The amplitude of the 120Hz frequency bucket was elevated

Figure 4.3: Accelerometer on in service pole

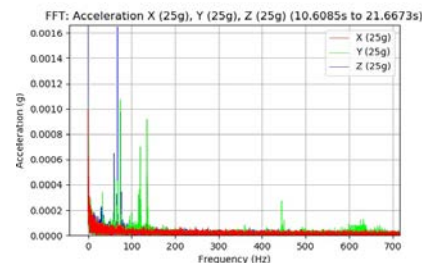
(b) Spectral content of ambient vibrations

in the measurements however there was no obvious correlation between the spectral content and the presence of heart rot or decay in the poles. This suggests that although the preliminary study shows promise, further analysis is required to show the phenomenology in a human interpretable manner.
